## **FIRE PERFORMANCE EVALUATION OF GLASBORD FPAUS IN ACCORDANCE WITH AUSTRALIAN STANDARD™ (AS) ISO 9705-2003, FIRE TESTS-FULL-SCALE ROOM TEST FOR SURFACE PRODUCTS**

**FINAL REPORT**  
Consisting of 20 Pages

**SwRI Project No. 01.24102.19.310**  
**Test Date: February 26, 2019**  
**Report Date: March 12, 2019**

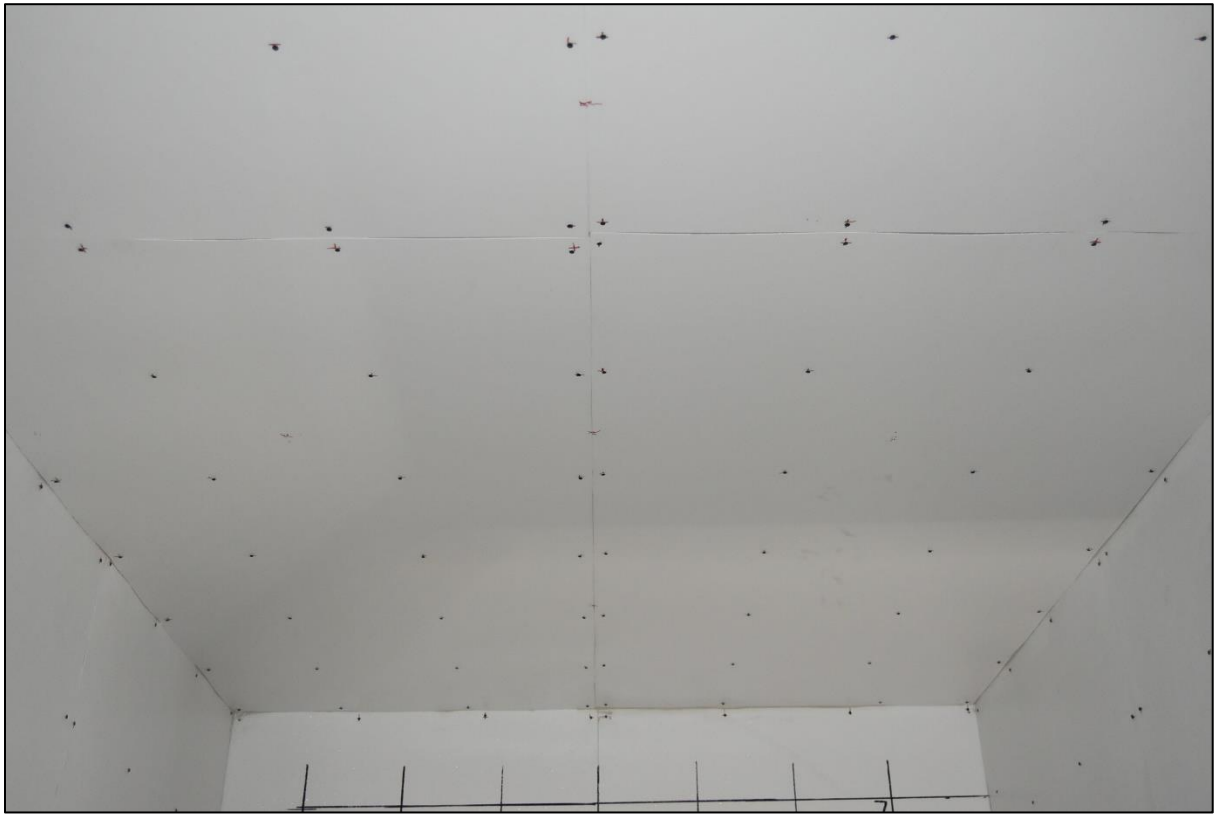
**Figure A-3. Pre-Test View of Ceiling.**

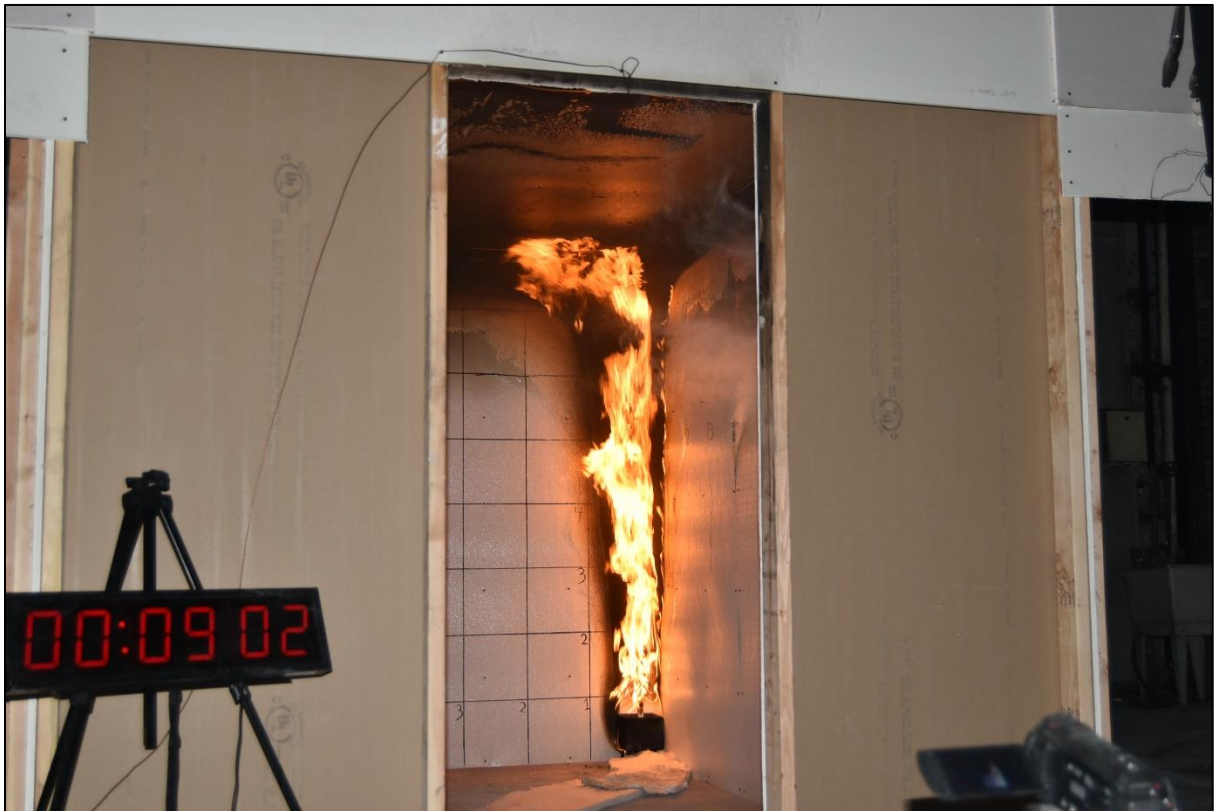
**Figure A-6. Test at 9 min 2 s, Burner Output of 100 kW.**

08:00	Burning only along the charred edges in a “V” area around the burner corner.
09:30	Very little active burner on the walls.
10:00	Burner increased to 300 kW.

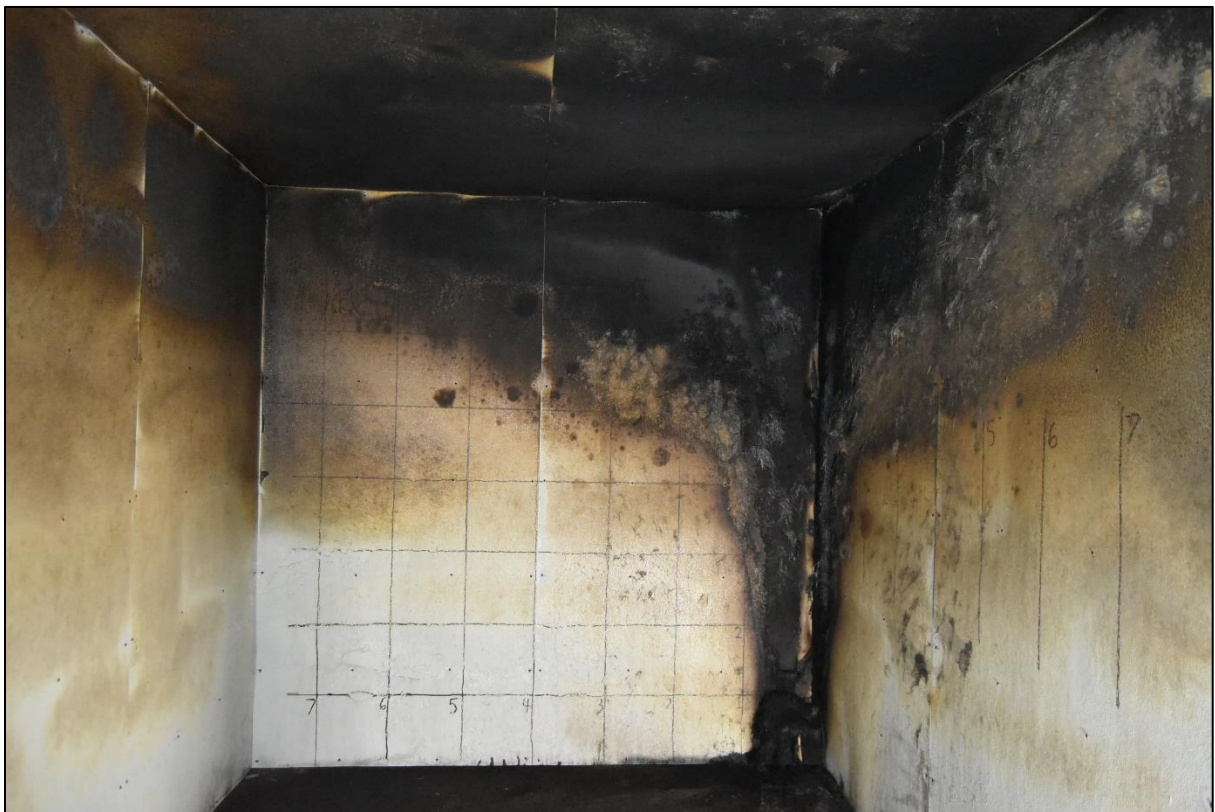
**Figure A-10. Post-Test View of Room.**

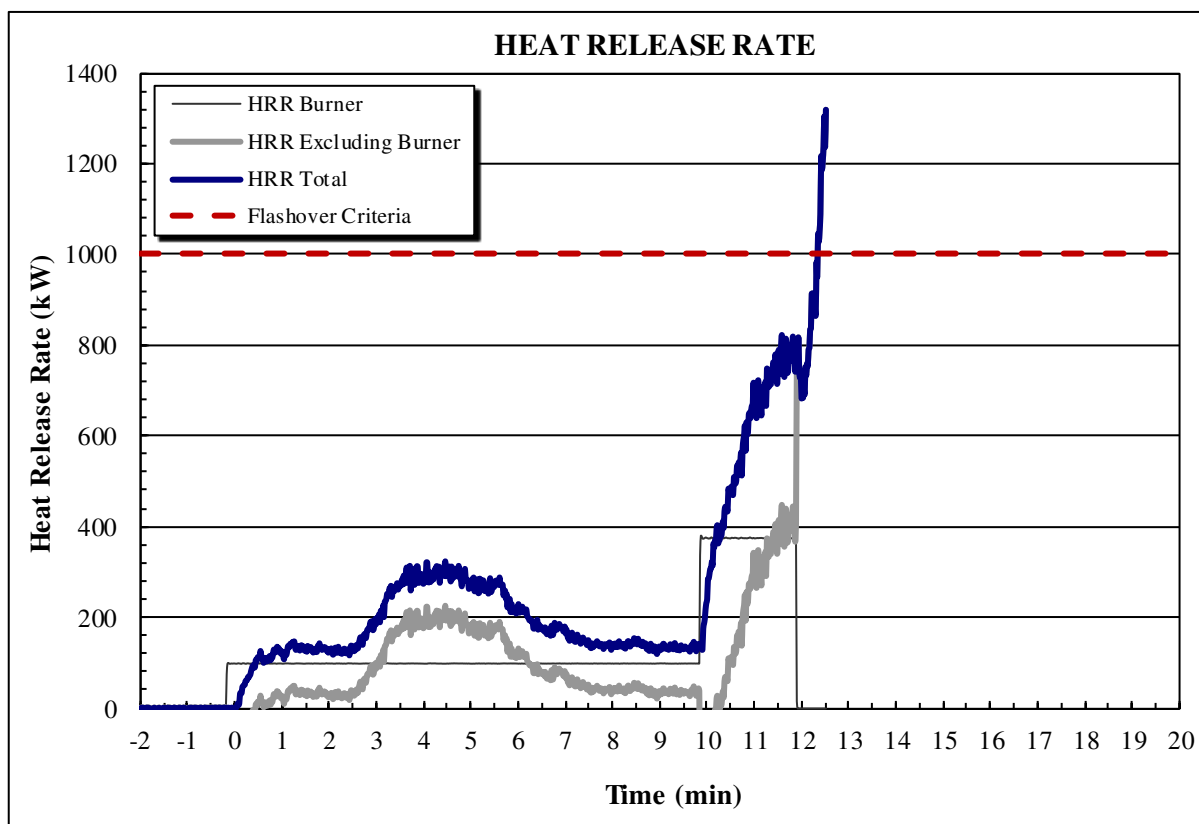
Maximum HRR <sub>total</sub>	1318 kW	at	12 min 32 s
Average HRR <sub>total</sub>	318 kW		
Total Heat Released	210 MJ		
Maximum HRR <sub>excl. burner</sub>	1318 kW	at	12 min 32 s
Maximum HRR <sub>excl. burner, 30 sec</sub>	967 kW		
Average HRR <sub>excl. burner</sub>	166 kW		
Total Heat Released (Excluding Burner)	109 MJ		
Maximum Smoke Production Rate	6.27 m <sup>2</sup> /s	at	11 min 41 s
Maximum Smoke Production Rate <sub>60 sec</sub>	4.58 m <sup>2</sup> /s	at	11 min 26 s
Average Smoke Production Rate	0.96 m <sup>2</sup> /s		
Total Smoke Released	636 m <sup>2</sup>		
Maximum Optical Density	0.99 1/m	at	11 min 43 s
Exhaust Duct Flow at Maximum O.D.	2.51 m <sup>3</sup> /s		
Average Optical Density	0.124 1/m		
Average Volumetric Duct Flow Rate	2.40 m <sup>3</sup> /s		
Maximum Heat Flux to the Floor	35.1 kW/m <sup>2</sup>	at	11 min 55 s
Max Average Ceiling Temperature	357 °C 675 °F	at	12 min 7 s
Maximum Doorway Temperature	564 °C 1048 °F	at	12 min 6 s

Maximum CO Production Rate	10.15 × 10 <sup>-3</sup> m <sup>3</sup> /s	at	12 min 30 s
Maximum CO Release Rate	11.62 g/s		
Maximum CO <sub>2</sub> Production Rate	0.075 m <sup>3</sup> /s	at	12 min 30 s
Maximum CO <sub>2</sub> Release Rate	135 g/s
